MANDATORY SERVICE BULLETIN

NUMBER: SB-012 **AMENDMENT 1**

SUBJECT: FUEL SYSTEM; MANDATORY INSPECTION (WING) **AMENDMENT 1**

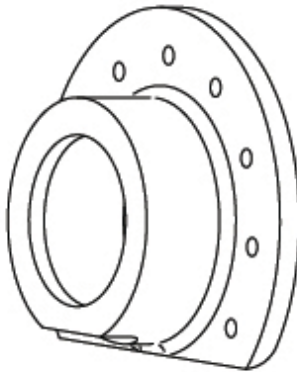
Figure 1: Fuel Tank Outlet Port

Quest is requiring a one-time inspection of the wing fuel tank outlet port connections. The inspection will consist of ensuring Pro-Seal fuel sealant is present on the threads of the fuel tank outlet port (P/N 100-828-4405).

Inspect the wing fuel tank outlet port connections as prescribed in the instructions attached.
