MANDATORY SERVICE BULLETIN

NUMBER: SB-028 REVISION: 01 **DATE:** June 7, 2013

SUBJECT: AFT FUSELAGE RIVET INSPECTION AND DOUBLER INSTALLATION

KODIAK 100 Series Aircraft Serial Numbers: 100-0001 through 100-0036

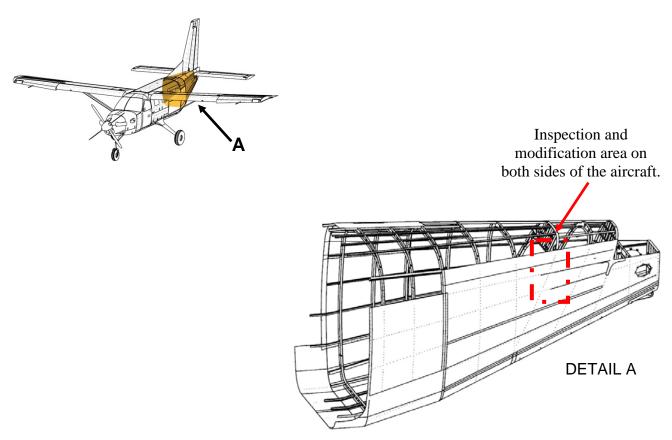
Figure 3-1: Inspection and Modification Area

This Field Service Instruction provides procedures for inspecting the exterior skin, and installing a doubler on the left and right side of the aft fuselage.

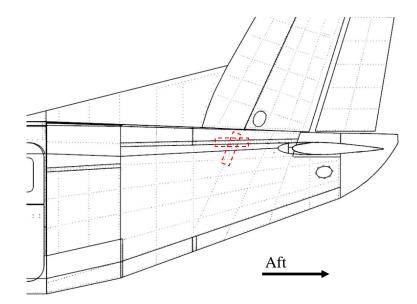
Figure 4-1: Inspection Area

Visually inspect the exterior of the aircraft indicated in Figure 4-1, on both left and right sides, for skin damage including:

- 1. Rivet heads that are pulled sharply into skin
- 2. Cracking around rivet holes.

If skin damage is present, contact Quest Aircraft Company for repair instructions.

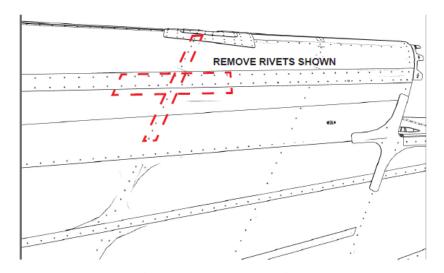
Figure 5-1: Remove Rivets

- 1. Visually inspect for cracks or severe dimpling at the empty rivet holes and the area under the rivet head in the area indicated in **Figure 5-1**.
- 2. If skin damage is present, contact Quest Aircraft Company for repair instructions.

Using acceptable industry practices, as found in FAA Advisor Circular AC 43.13-1B, remove the rivets that attach the skin to the frame as shown in **Figure 5-1**.

It may be necessary to remove more rivets than shown in **Figure 5.1** to loosen skin and install the doubler as described in **Section 5.3**. Ensure that skin is loosened enough that doubler can be inserted without excessive force that would result in loss of corrosion protection on the doubler or the skin.
