MANDATORY SERVICE BULLETIN**NUMBER:** SB14-04**REVISION:** 00**DATE:** June 10, 2014**SUBJECT:** SLINGER RING INSPECTION**EFFECTIVITY:**

TKS™ Equipped KODIAK® 100 Series Aircraft Serial Numbers: 100-0001 thru 100-0092

Slinger Ring Inspection

FSI-074

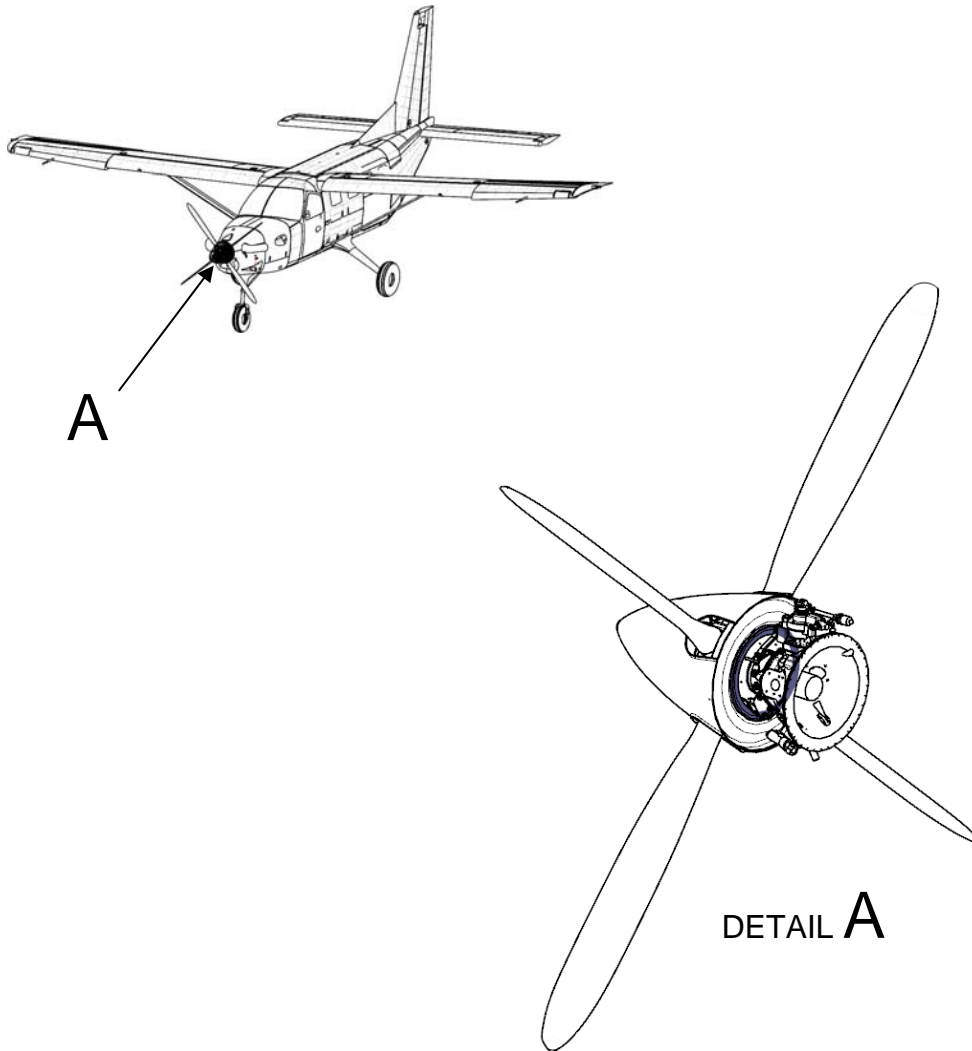
Figure 3-1: Propeller TKS™ Slinger Ring Overview

This Field Service Instruction provides instruction to inspect the propeller slinger ring on TKS™ equipped airplanes to ensure proper clearance between the aft face of the propeller slinger ring and the propeller reversing lever (also known as the beta arm).

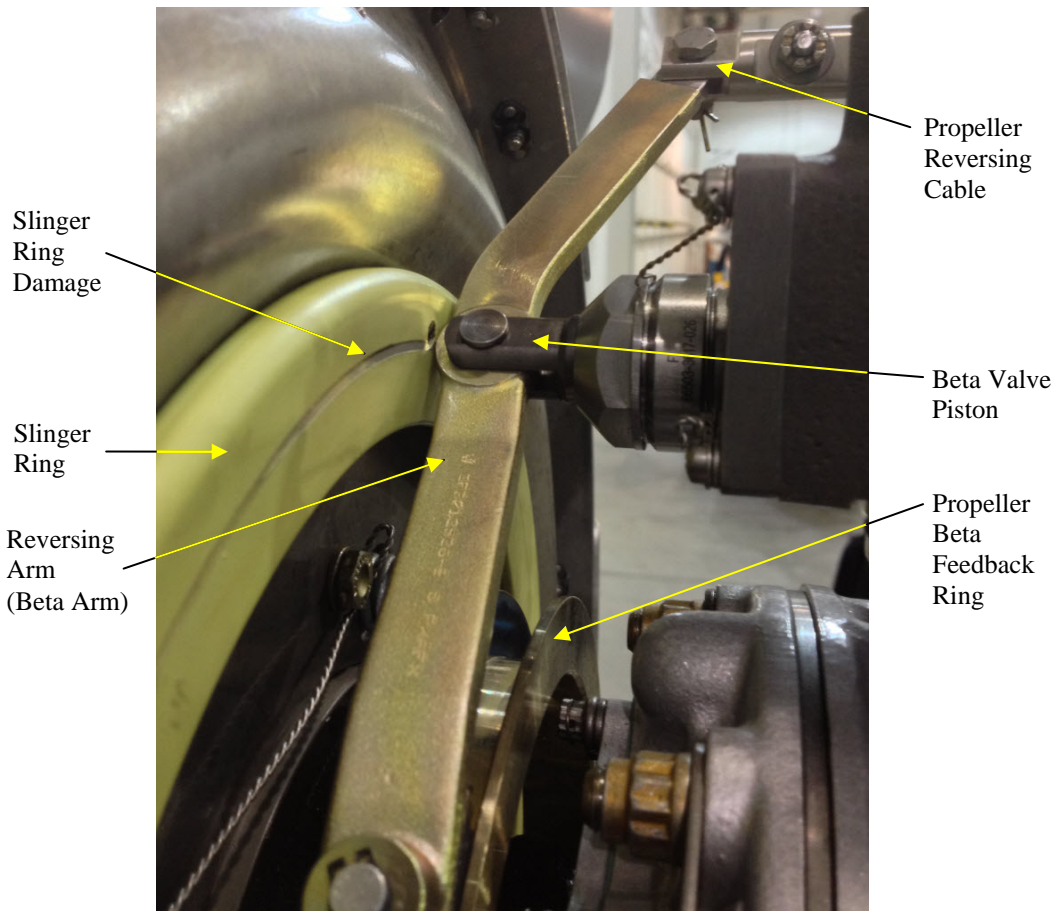
Figure 5-1: Damaged Slinger Ring Example

1. Visually inspect the aft face of the propeller slinger ring (P/N 13025-1) for any sign of rubbing or scoring of the aft face as shown in **Figure 5-1**. An undamaged slinger ring will be free of any marks or scoring of the aft surface.

2. If no damage is visible, proceed to **Section 5.2**.
3. If damage to the slinger ring is visible, examine the beta arm:
 - a. If damage to the beta arm is limited to the surface plating, note in the maintenance schedule the requirement to perform Quest Aircraft Company FSI-084 *Slinger Ring Replacement* and replace the beta arm at next scheduled annual or 100-hour maintenance interval. Proceed to **Section 6**.
 - b. If damage to the beta arm has progressed beyond the plating and any portion of the beta arm base material has been removed, perform Quest Aircraft Company FSI-084 *Slinger Ring Replacement* and replace the beta arm prior to the next flight. Proceed to **Section 6**.

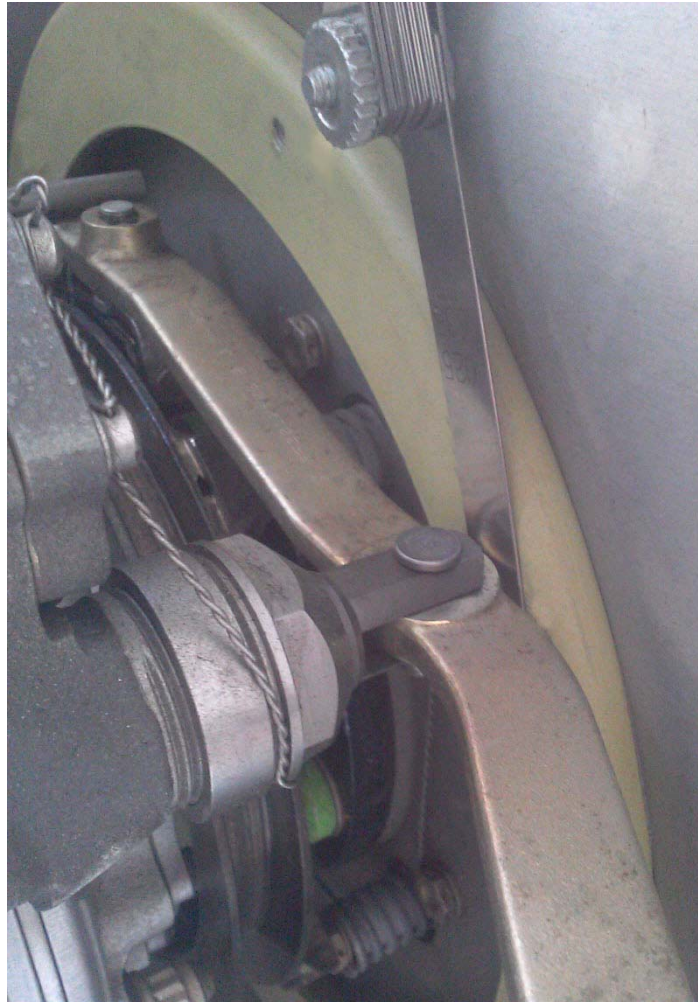
Figure 5-9: Measure Beta Arm/Slinger Ring Gap

1. With a feeler gauge, measure the gap between the beta arm and the aft face of the slinger ring. Refer to **Figure 5-9**.

- c. If the gap is greater than or equal to .025 inch, record a reminder in the airplane maintenance records to perform Hartzell Propeller Inc. Service Bulletin HC-SB-30- 352 at the next propeller overhaul.
- d. If the gap is less than .025 inch, record a reminder in the airplane maintenance records to perform Quest Aircraft Company FSI-084 *Slinger Ring Replacement* at the next 100 hour or annual maintenance inspection.
