MANDATORY SERVICE BULLETIN**NUMBER:** SB14-05**REVISION:** 00**DATE:** June 12, 2014**SUBJECT:** FLAP ACTUATOR DRIVE CABLE NUT TORQUE**EFFECTIVITY:**

KODIAK® 100 Series Aircraft Serial Numbers: 100-0001 thru 100-0085

FIELD SERVICE INSTRUCTION

TITLE: Flap Actuator Drive Cable Nut Torque
SERIAL RANGE: 100-001 thru 100-0085
JASC CODE: 2750

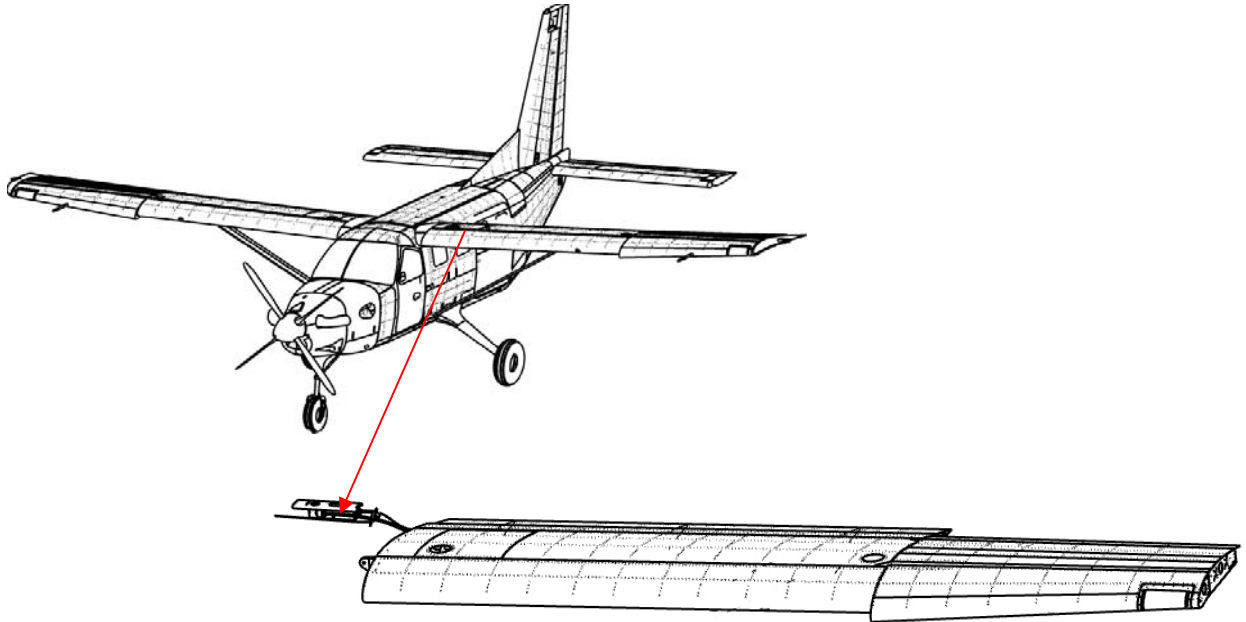
Figure 3-1: Overview

The flap actuator drive cable nuts at the gearbox controller must be inspected on both sides of the aircraft to verify that the nuts have not been damaged by over-torquing during installation or maintenance. This inspection should be completed at the next annual inspection or if maintenance is performed on the flap actuation system prior to the annual inspection.

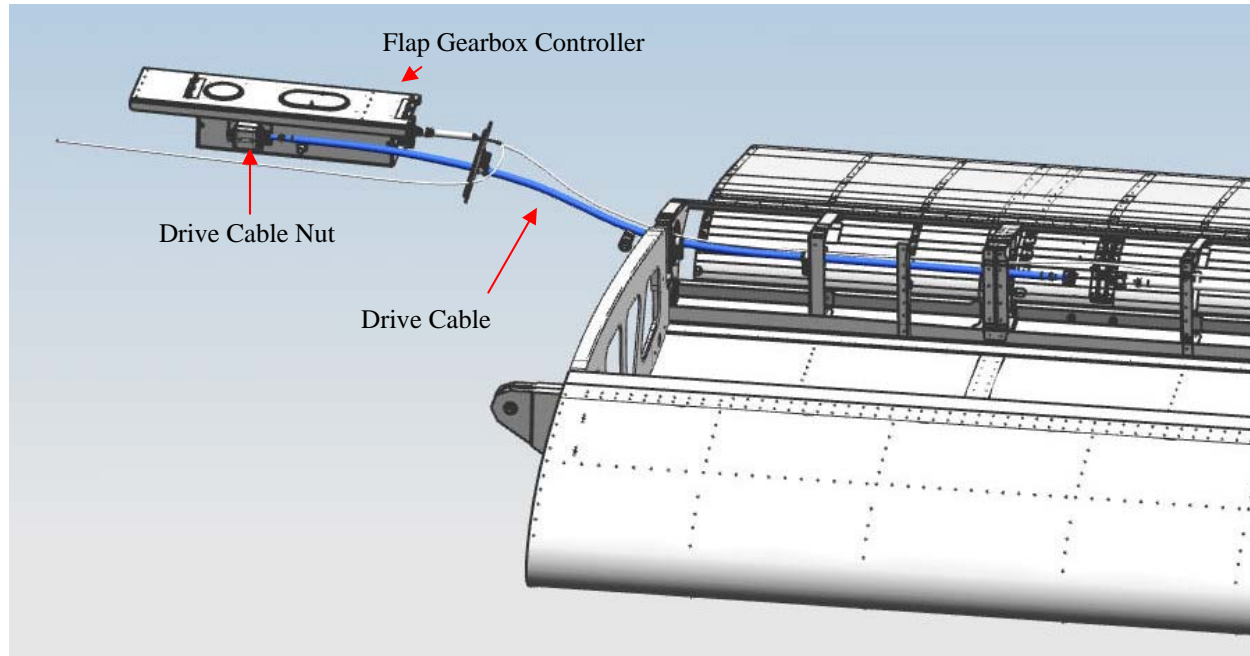
Figure 5-1: Flap Gearbox Controller, Drive Cable, and Drive Cable Nut

1. Remove the safety wire at the flap actuator drive cable nut.
2. Disconnect the flap actuator drive cable nut at the flap gearbox controller (**Figure 5-1**).

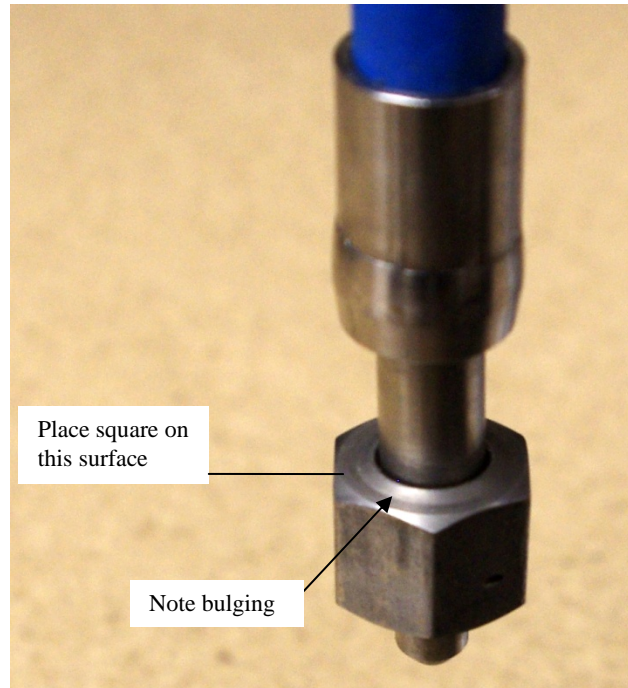
Figure 5-2: Yielded or Bulging Drive Cable Nut

3. Inspect the drive cable nut, noting any cracks, bulges, or yielding (**Figure 5-2**).
4. Verify that the back of the nut is flat by placing a small square across the back of the nut (**Figure 5-2**).
5. Repeat steps 1 through 4 on the opposite side of the aircraft.

- If damage is found:
 1. Contact Quest Customer Service for product replacement information.
 2. Proceed to Section 5.2.
- If no damage is found:
 1. Reconnect the drive cable nut and torque to 47 – 53 in-lb.
 2. Re-install the safety wire.
 3. Proceed to Section 5.3.

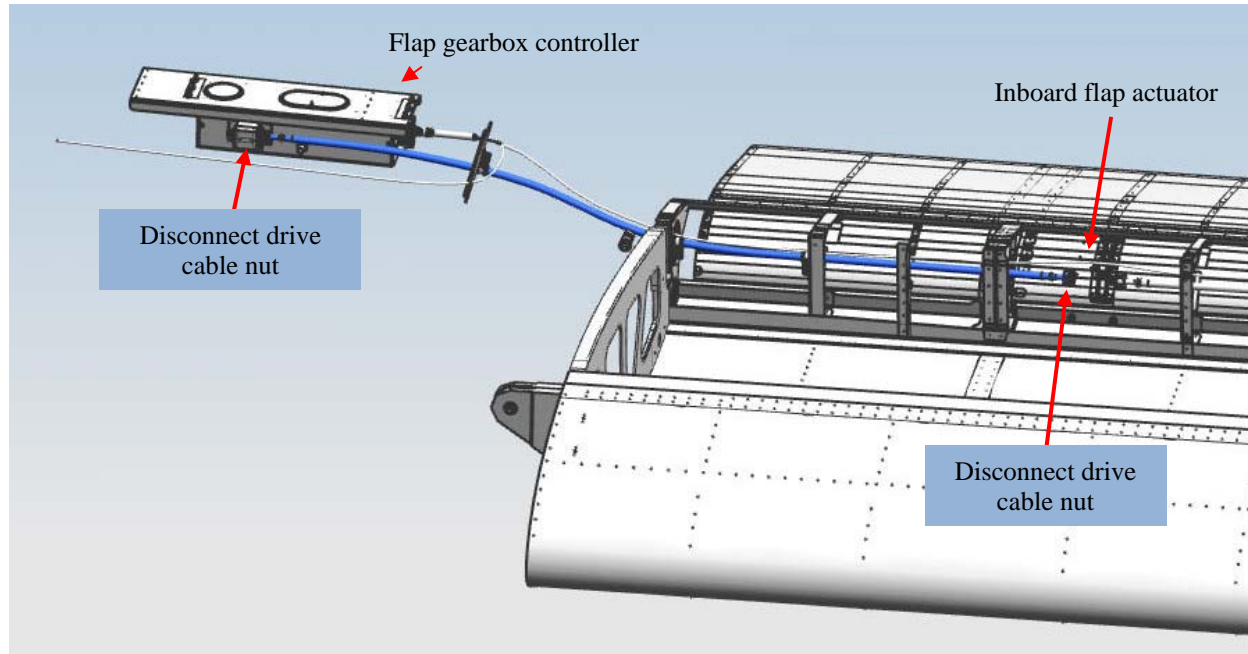
Figure 5-3: Disconnection Points for Drive Cable Nuts

1. Remove the headliner in accordance with the *KODIAK 100 Airplane Maintenance Manual*, Chapter 25.
2. Remove the safety wire at the inboard flap actuator (**Figure 5-3**).
3. Disconnect the flap actuator drive cable nut at the at the inboard flap actuator (**Figure 5-3**).

4. Remove the cushion loop clamps and zip ties that fasten the drive cable to the frame.
5. Remove and discard the damaged drive cable(s).
6. Install the replacement drive cable(s):

7. Torque the cable nut at the gearbox controller to 47 – 53 in-lb, and the cable nut at the inboard flap actuator to 160 – 170 in-lb.

The drive cable nuts at each end of the cable are different sizes and require different torque values.
