MANDATORY SERVICE BULLETIN

NUMBER: SB-001
REVISION: B
DATE: 06/01/2010

SUBJECT: FLAP SYSTEM, Flap Actuation; Mandatory Inspection Procedures

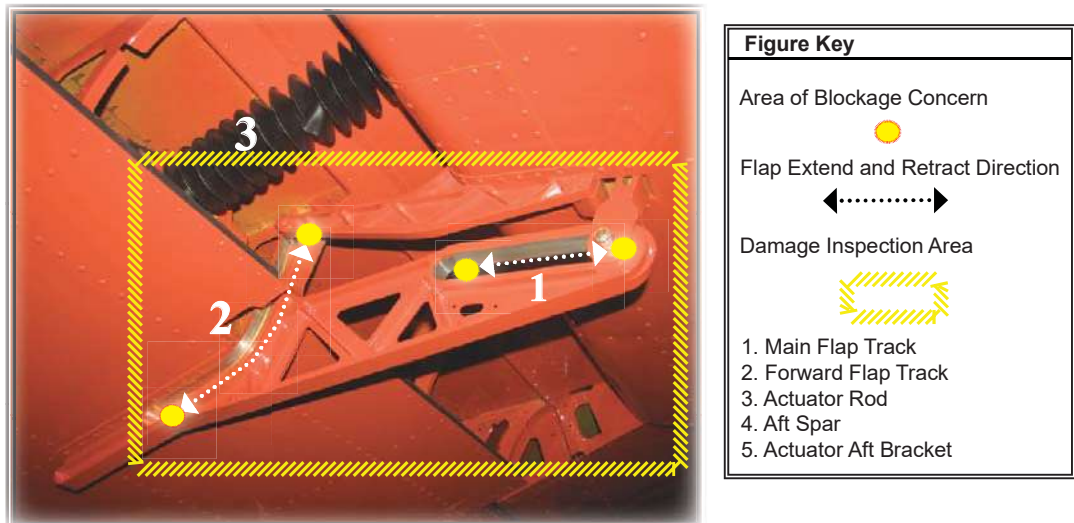
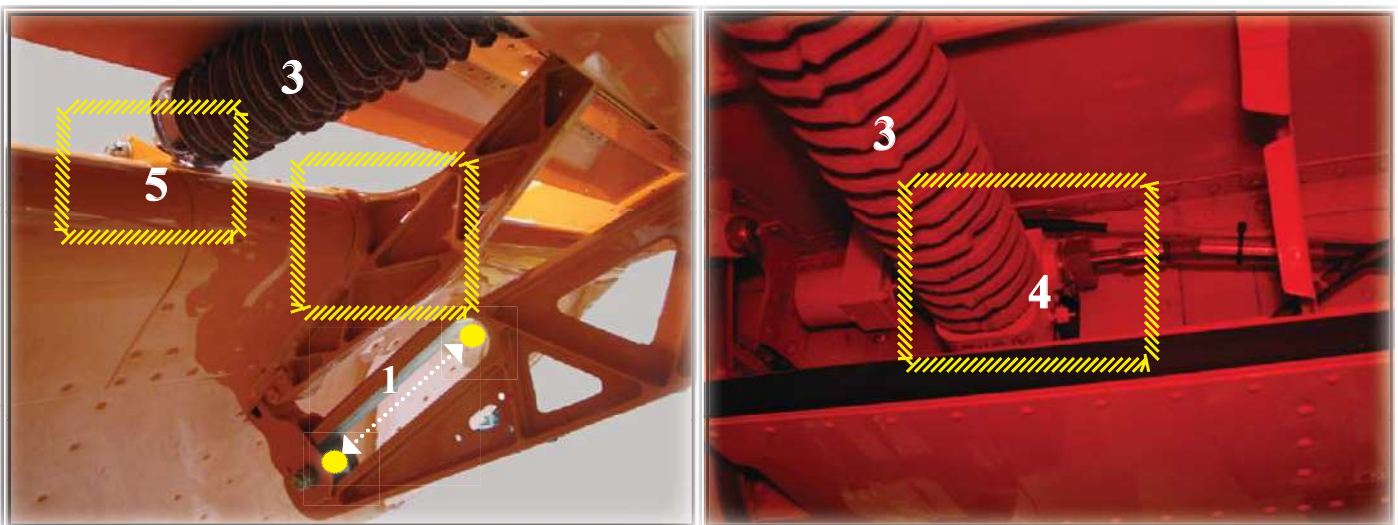
Figure 2: Inspection Areas

In a recent technical evaluation of the KODIAK100 flap system, it was found that if the flaps are operated with the temperature below +5°C (+41°F) and there is a blockage in the flap track (build-up, debris), damage to the flap could occur.

The illustrations in this section highlight the visual inspection areas that require special attention.

Pilots must inspect to avoid the potential situation. When operating in temperatures below +5°C (+41°F), pilots must ensure that all debris are removed from the main flap tracks. During cold weather operations, if the aircraft takes off in snow or slush, visually check the main flap tracks for any debris build-up that may have occurred. If build-up has formed after takeoff or in-flight, **DO NOT** operate the flaps. Follow the guidance listed in the KODIAK 100 Pilot Operating Handbook/Aircraft Flight Manual to perform a 0° flap landing. If the flap tracks became blocked during takeoff, leave the flaps in the takeoff setting (normally 20°) and return to the airfield. A revision to the Pilots Operating Handbook/Aircraft Flight Manual and abbreviated checklist will be issued in the near future adding flap inspection procedures. Use the procedures below to perform the inspection.

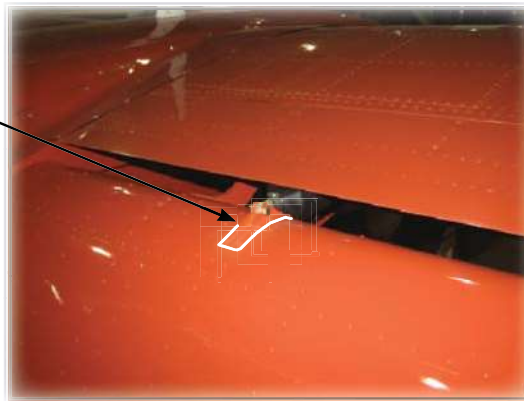
Figure 3: Upper Flap Surface

Upper Wing and Flap Surface
(Flap Connection Point Outlined in White)

During the Exterior Preflight Inspection, visually check the forward and main flap tracks (12 total) to ensure that debris has not become lodged in the track and that there was no damage to the flaps during the previous flights. In addition, inspect the upper and lower wing surfaces for signs of debris build-up. See **Figure 3**.
