MANDATORY SERVICE BULLETIN**NUMBER:** SB-007**DATE:** 4/2/2009**SUBJECT:** AMSAFE MANDATORY INERTIA REEL TEST**SUMMARY****RECURRENT REQUIREMENTS**

INSPECTION / CHANGE OF RESTRAINT SYSTEM ASSEMBLY
WITH INERTIA REEL AND MANUAL LOCK HANDLE

SERVICE BULLETIN NUMBER 4119-25-01 ISSUE 1

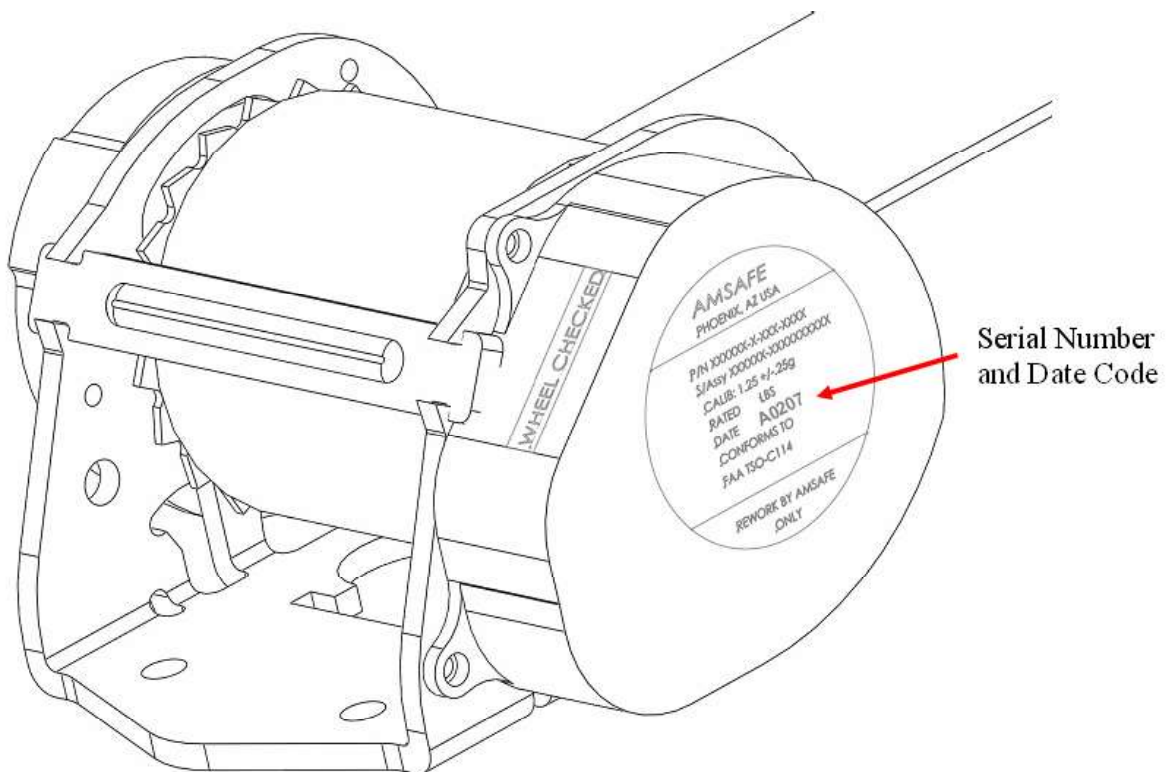
Figure 1 – Serial Number and Date Code Information

1. The inspection of the restraint system does not require the restraint system to be removed from the seat.
2. Date Code Inspection. The date code can be found on the inertia reel identification label see Figure 1. For access to the inertia reel identification label please refer to the applicable seat manufactures instruction defined in their CMM.

If the date code is prior to 1 Feb 07 (X0207) or after 30 Nov 08 (X1108) no further action is required.

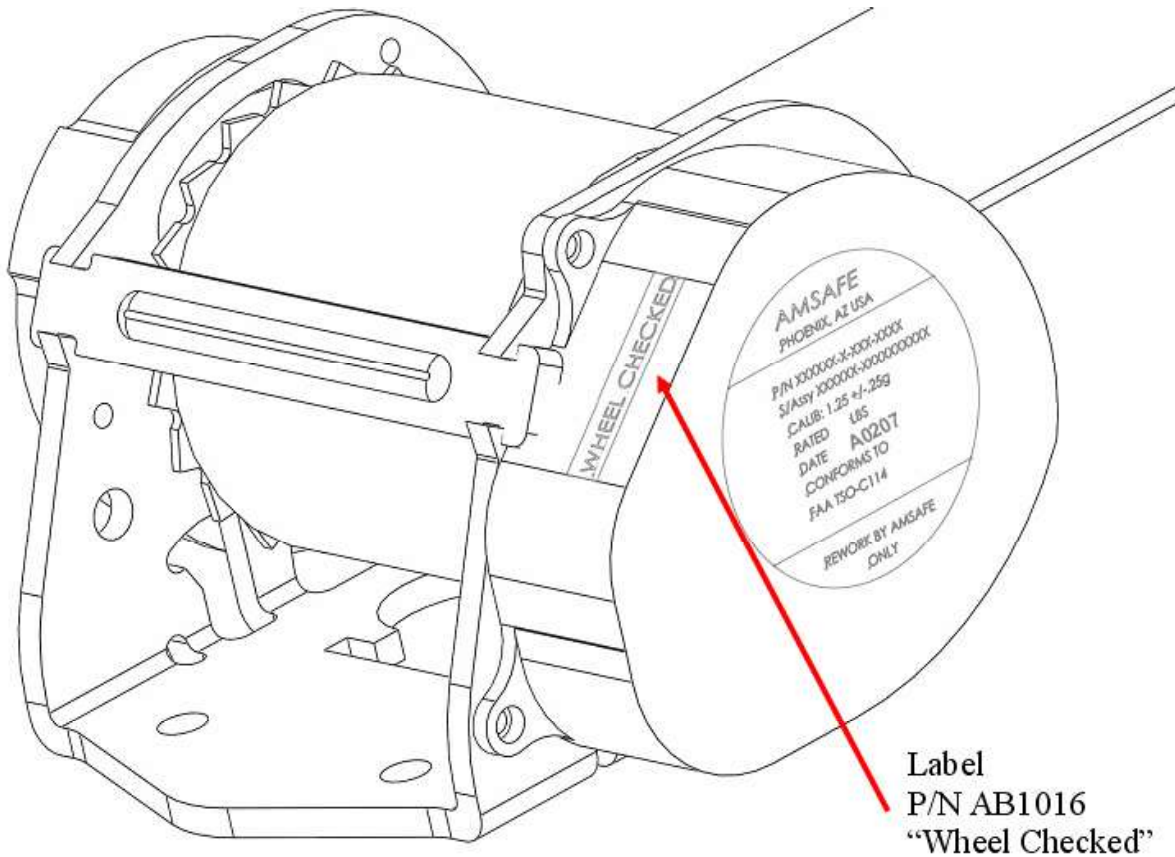
Figure 2 – Wheel Checked Label

If the serial number is between 1 Feb 07 (X0207) and 30 Nov 08 (X1108), and the inertia reel does not include a label attached by AmSafe stating "Wheel Checked" (Figure 2) continue to step 3.
