# \*MANDATORY SERVICE BULLETIN\*

NUMBER: SB11-14

#### **SUBJECT: WINDSHIELD BOND-LINE INSPECTION**

KODIAK 100 Series Aircraft Serial Numbers: 100-0001 Through 100-0054

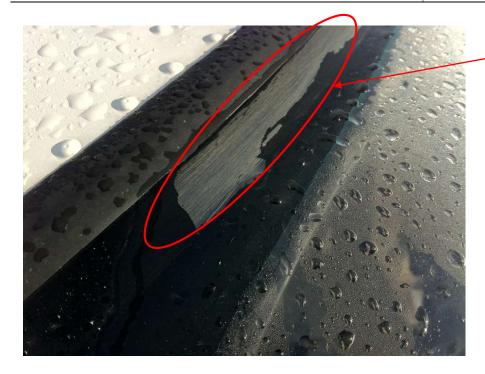
De-bonding of Primer

- 1. Temporarily remove the center windshield strap.
- 2. Inspect the molding around the perimeter of the windshield for security of installation.
- 3. Inspect the perimeter of the windshield for the primer de-bonding from the aircraft windshield, as shown in the pictures below.
- 4. Reinstall the center windshield strap.
- 5. If de-bonding of the molding or primer is detected, contact Quest Aircraft Company for further instructions.

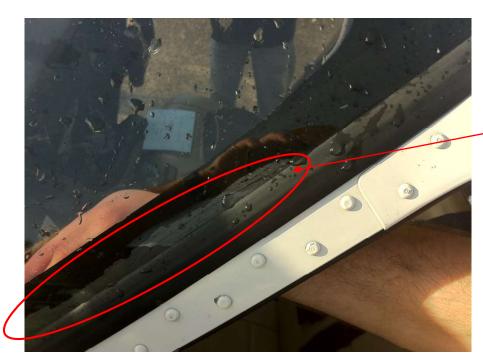
De-bonding of Primer
