MANDATORY SERVICE BULLETIN

NUMBER: SB11-15

SUBJECT: Crew Seat Chain Plate Inspection

100-0001 through 100-0054. (All Quest Aircraft Type Certified interior configurations.)

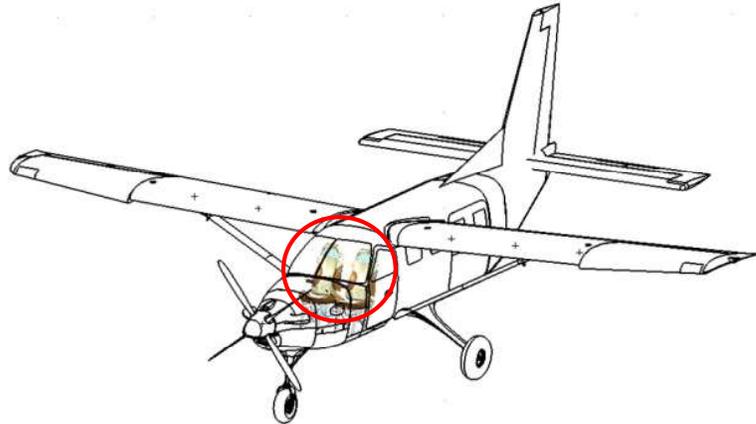
Inspection Area:

It has been found on one aircraft with over 1,000 flight hours that a crack has started to form around the nut on the crew seat chain plate, as shown on the next page. The damage is caused by users adjusting the seat height beyond its upper limit. (Adjustment arm located on the front of the crew seats between the occupant's legs.) *Quest Aircraft Company* is mandating a one-time inspection of this bracket to bring special attention to mechanics. This inspection does not change or modify the inspection requirements as defined in the *KODIAK 100 Maintenance Manual, Chapter 5 "Time Limits/Maintenance Checks."*

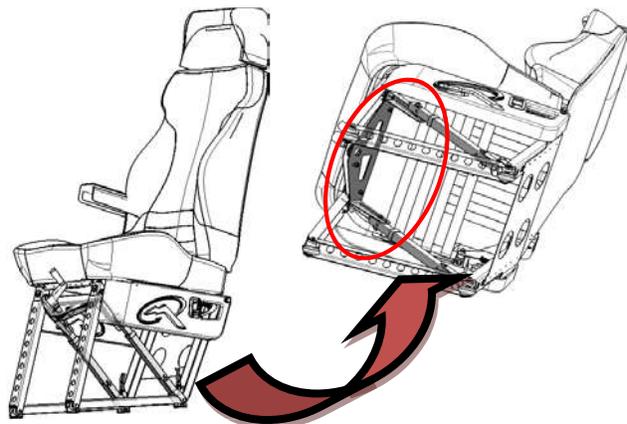
1. Gain access to the bottom of the crew seat.

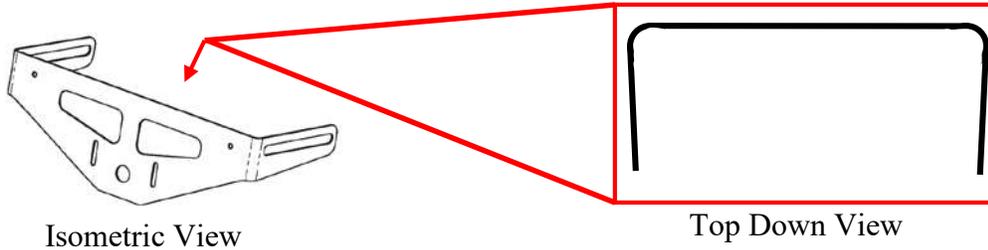
2. Inspect the Crew Seat Chain Plate (P/N 100-825-1231) for:
 - 2.1. Correct shape (See image below).

- 2.3. If brackets are incorrectly bent or cracks are found, the part(s) must be replaced. Contact Quest Aircraft Customer Service to order replacement parts.
 - 2.4. If no damage is found, continue to **Step #3**.
3. Repeat inspection procedure on the other crew seat.
4. Upon completion of all work instructions, record work completed in the appropriate *Kodiak 100 Log Books*.

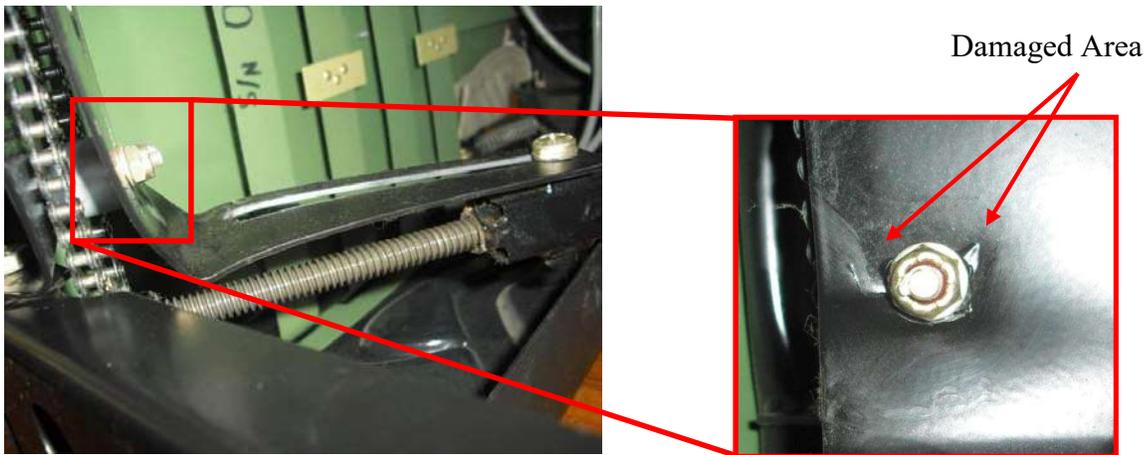
- 2.2. Cracking and other deformation/damage (See images below).
