MANDATORY SERVICE BULLETIN**NUMBER:** SB-010 **AMENDMENT 1****DATE:** 06/09/2009**SUBJECT:** FUSELAGE; VERTICAL TAIL BOLT INSPECTION **AMENDMENT 1****SUMMARY**

This is an amendment to SB-010 for the mandatory Vertical Tail Bolt Inspection of the KODIAK 100. Quest has discovered that the washer part number callout in the previous Service Bulletin was incorrect and is reissuing work instructions with the correct part numbers identified.

**SB-010 Vertical Tail Bolt Inspection
AMENDMENT**

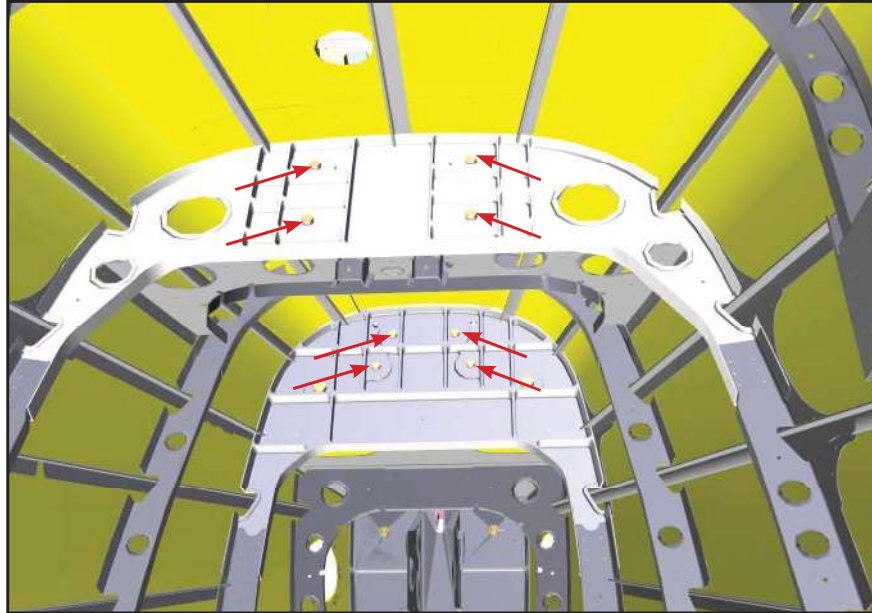
Figure 1 - Bolt Locations

Locate the **8** vertical tail attachment bolts.

See **Figure 1** for assistance in identifying these 8 bolts within the vertical tail. **Figure 2** shows a close-up view of the bolts that must undergo inspection.

Remove the tail cone and the aft bulk head as described in the **KODIAK Maintenance Manual**.
