RECOMMENDED SERVICE LETTER**NUMBER:** SL-004**DATE:** 10/10/2008**SUBJECT:** COCKPIT; One-Time Pilots Side Control Pedestal Bolt Inspection**SUMMARY**

Bolt Inspection Directions and Reversal *(if required)*

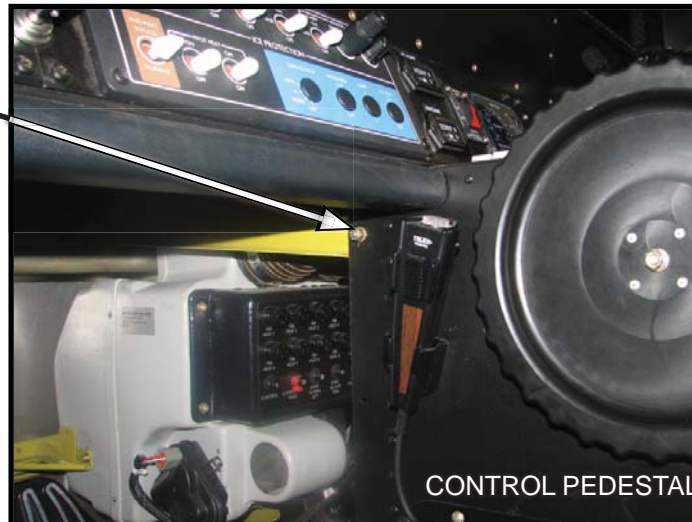
FIGURE 1 : Bolt Inspection Location (Pilot's Side)

The Control Pedestal is the center console in the cockpit between the pilot and copilot. The Control Pedestal houses the Throttle Quadrant, Main Circuit Breaker Panel, and the Manual Trim Wheel. The bolt that requires inspection is located on the pilots side and in the forward portion of the Control Pedestal. See **FIGURE 1**.

BOLT TO BE INSPECTED

Inspect the bolt shown in **FIGURE 1** to ensure that the bolt is installed with the nut on the exterior of the Control Pedestal. See **FIGURE 2 & 3** below for correct and incorrect installation depictions.

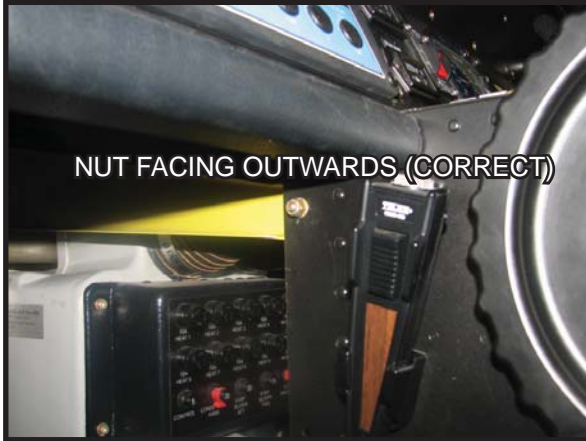
FIGURE 2 : Correct Installation

Correct Installation (no further action required)

If the bolt is installed **CORRECTLY** as it is in **FIGURE 2**, no further action is required. Please call Quest Aircraft Customer Service at (208)-263-1111 and inform Quest Aircraft of the orientation of the bolt on your aircraft.

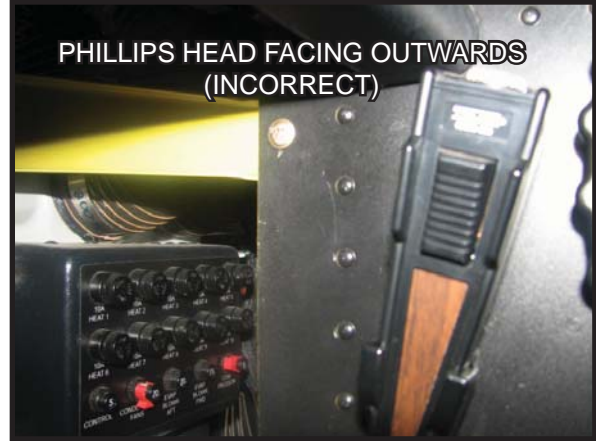
FIGURE 3 : Incorrect Installation

Incorrect Installation (bolt reversal required)

If the bolt is installed **INCORRECTLY** as it is in **FIGURE 3**, complete the following steps:

1. Remove the bolt using a #2 Phillips Screwdriver and a 3/8" Open End Wrench.

2. Reinstall the bolt using the tools listed in step one making sure the nut is on the outside of the Control Pedestal as shown in **FIGURE 2**.

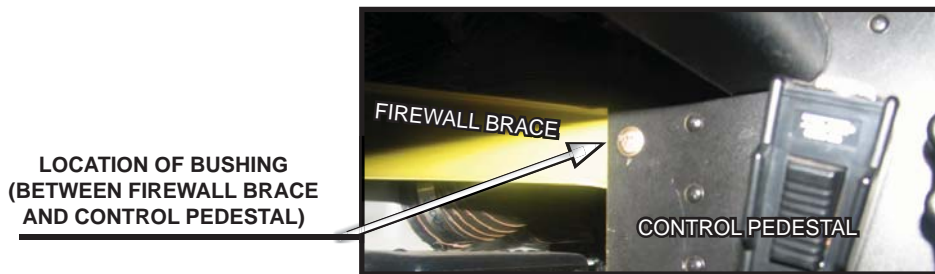
FIGURE 4 : Bushing Location

NOTE: A METAL BUSHING IS LOCATED BETWEEN THE CONTROL PEDESTAL AND THE BRACE CONNECTING THE CONTROL PEDESTAL TO THE FIREWALL. WHEN REMOVING THE BOLT, ENSURE THAT THE METAL BUSHING DOES NOT FALL OUT AND IS PRESENT WHEN REINSTALLING THE BOLT.
