MANDATORY SERVICE BULLETIN**NUMBER:** SB14-04**REVISION:** 00**DATE:** June 10, 2014**SUBJECT:** SLINGER RING INSPECTION**EFFECTIVITY:**

TKS™ Equipped KODIAK® 100 Series Aircraft Serial Numbers: 100-0001 thru 100-0092

Slinger Ring Inspection

FSI-074

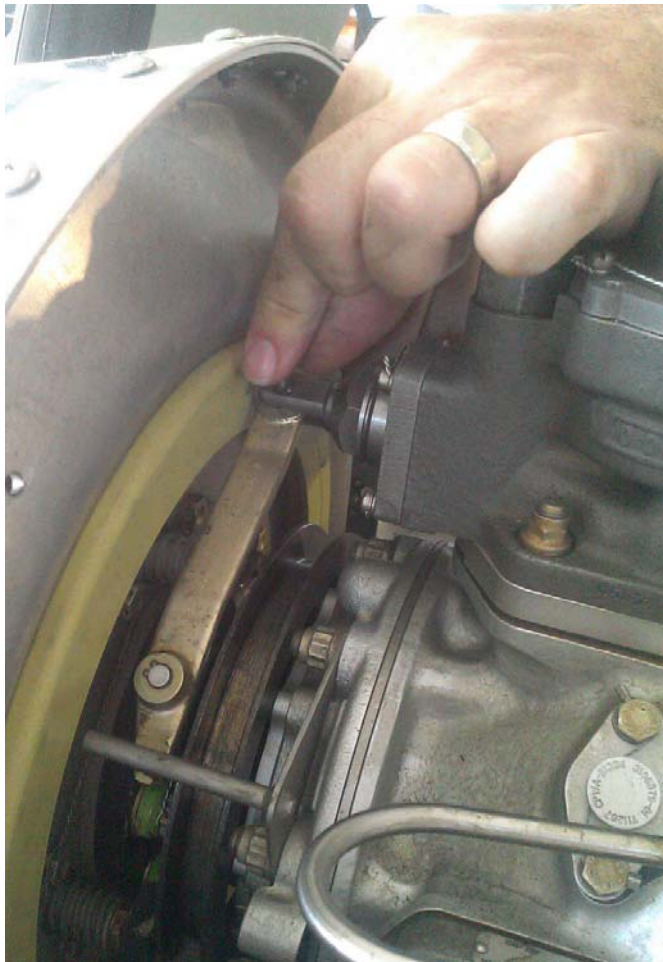
Figure 5-8: Extend Beta Valve Piston

The beta valve is spring loaded to the full-forward position. To confirm that the beta valve is firmly seated against the full-forward stop, apply hand pressure to push the valve aft, then pull it forward again. The internal beta valve forward stop is detected as a firm abrupt (metal to metal) contact point.

4. Extend the beta valve piston fully forward.
 - a. Install the clevis pin to connect the beta arm to the beta valve piston.
Refer to **Figure 5-7**.
 - b. Apply hand pressure to the beta arm to extend the beta valve piston fully.
Refer to **Figure 5-8**.
